Eldorado Dredge

Visitor Guide

Cock's Eldorado Dredge has remained in its final mooring place at Eldorado 20km east of Wangaratta since 1954. It was tied up here after operating for 18 years and winning 70,664 ounces of gold and 1,383 tons of tin concentrate from the rich alluvial plain of Reedy Creek.

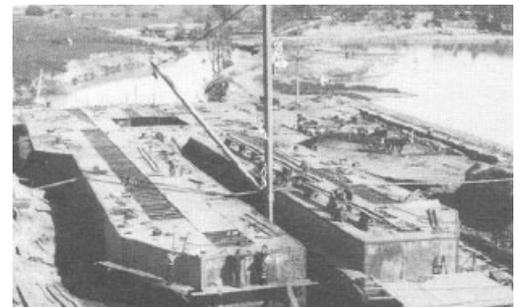
The dredge taking shape – Photo courtesy Eldorado Historical Society

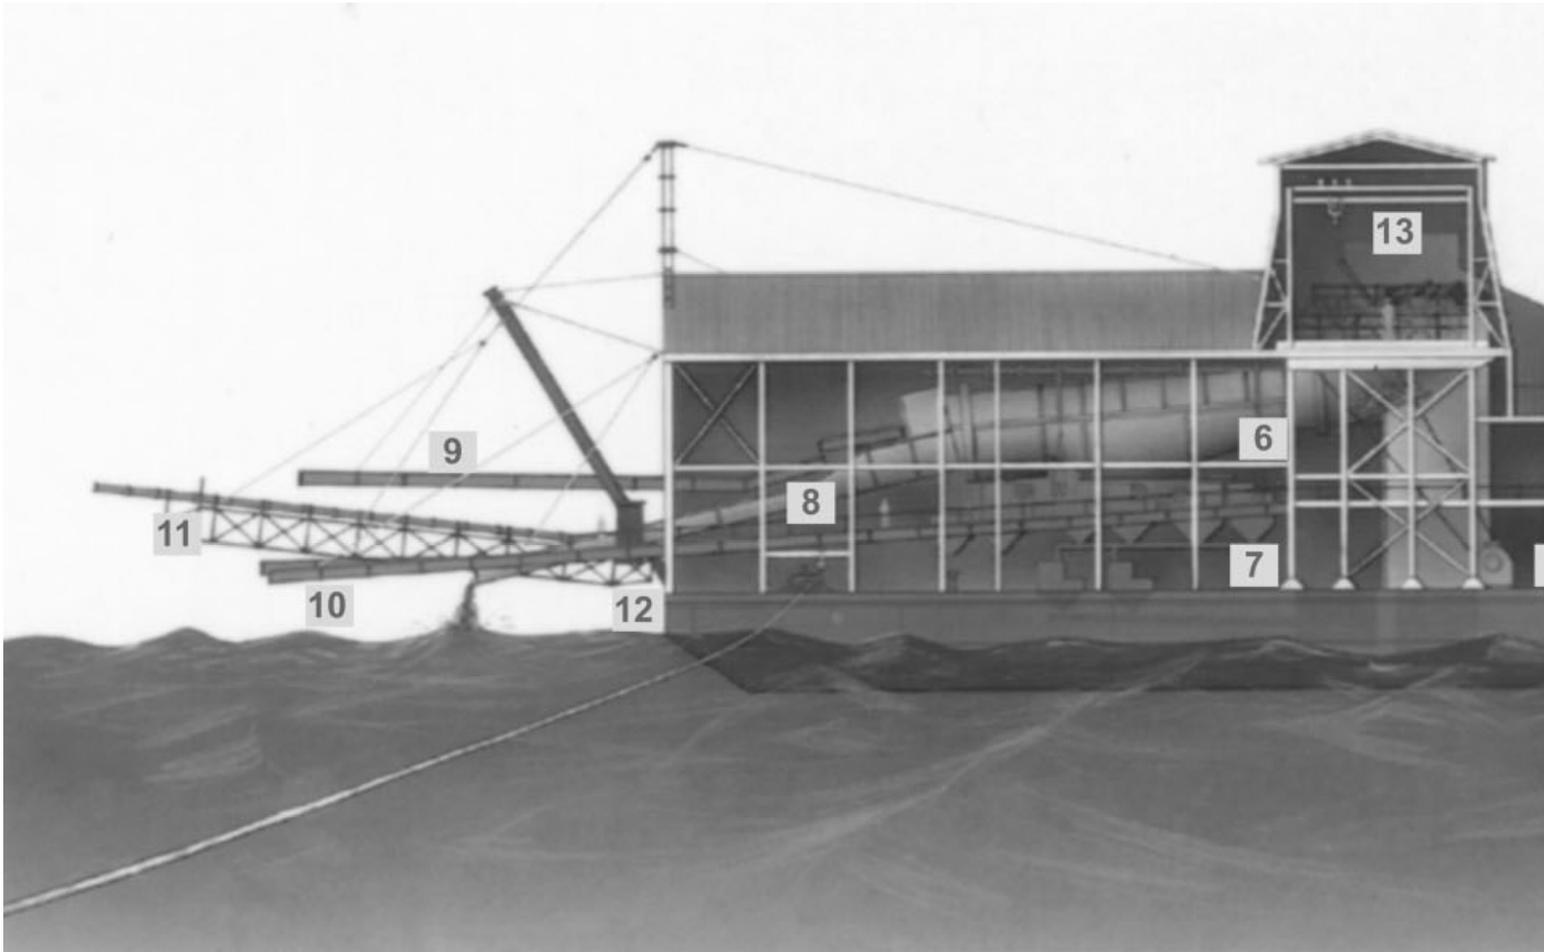
Numbers in () refer to numbers on the diagram overleaf.

An endless belt with about 110 steel buckets did the actual dredging. The buckets, carried on a moveable arm called the bucket ladder (1), cut into the alluvium (gold and tin bearing earth) with an action similar to a slow moving chainsaw.

The digging end of the bucket ladder was moved by an elaborate set of pulleys and cables visible on the fore gantry (2) across the bow of the dredge. The operator could adjust the depth of the dig to 98 feet (30m) below water, or raise the ladder above water for maintenance. Two steel cables ran from the fore gantry to a 160 hp double drum winch (3) mounted on the deck which raised and lowered the bucket ladder.

The small crane with a latticework of supporting struts is the jib crane (4) used to remove and replace buckets needing repair, a routine task during weekly maintenance shut-downs on Thursday and Sundays.

The dredge's onboard treatment plant consisted of a large rotary screen or sieve (6), and various jigs (agitators) (7). The plant separated out the small proportion of gold and tin in the alluvium and discarded the bulk of the material which was ejected from chutes or a pipe at the stern.

Course gravel and stones were caught in the rotary screen, passed into the lower semi-circular "stone-chute" (8) and discharged from the stern, fairly close to the dredge.

Poor grade material was simply ejected via the upper semi-circular chute (9). Gold and tin bearing alluvium went through primary and secondary jigs to separate the metals.

The waste material from the primary jigs was discharged as a slurry into open troughs or "launders" (10) running down each side of the dredge and protruding from the stern.

Fine waste from the secondary jigs was pumped through the long pipe suspended from the stern on a lattice frame (11), and discharged on top of the course gravel and stones.

Near the stern of the dredge you will notice a small tin shed perched precariously on railings over the dredge pond. This "dunny" (12) was one of the very few staff amenities on board.

The beam (13) extending out over the water was used to lift heavy equipment on and off the dredge.

An elaborate system of electrical switches and meters (15) controlled the various motors and other equipment.

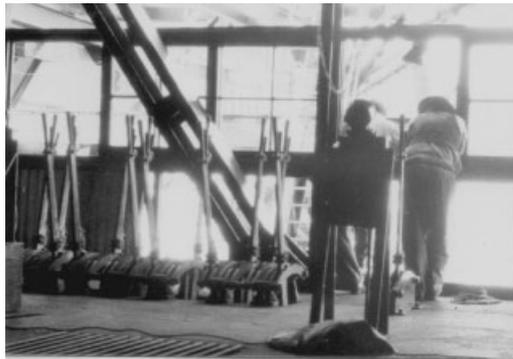
The control room c 1936 – Photo courtesy Eldorado Historical Society

Mechanical levers were used to start or stop the winch (16) motors. These winches in turn controlled all movement of the dredge including the bucket ladder and band.
